LAWRENCE
LIVERMORE
NATIONAL
LABORATORY

LLNL-TR-648143

A Visual Description of the Concrete Exterior of the Cactus Crater Containment Structure

October 2013

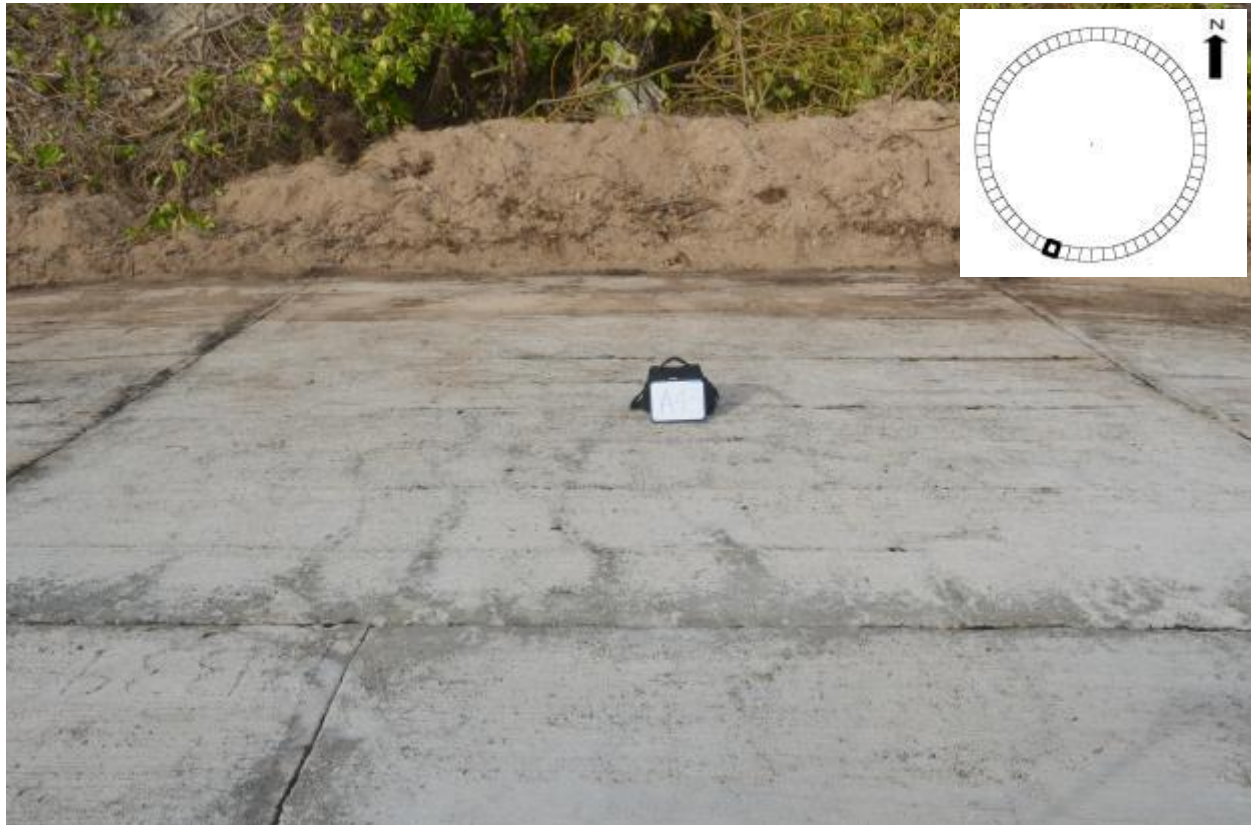
CAP SECTION LOCATION: Panel A43

No significant or obvious interior cracks extending across the top of the panel. The panel has a relatively rough and weathered appearance. Rooting vegetation removed from along the panel seams.

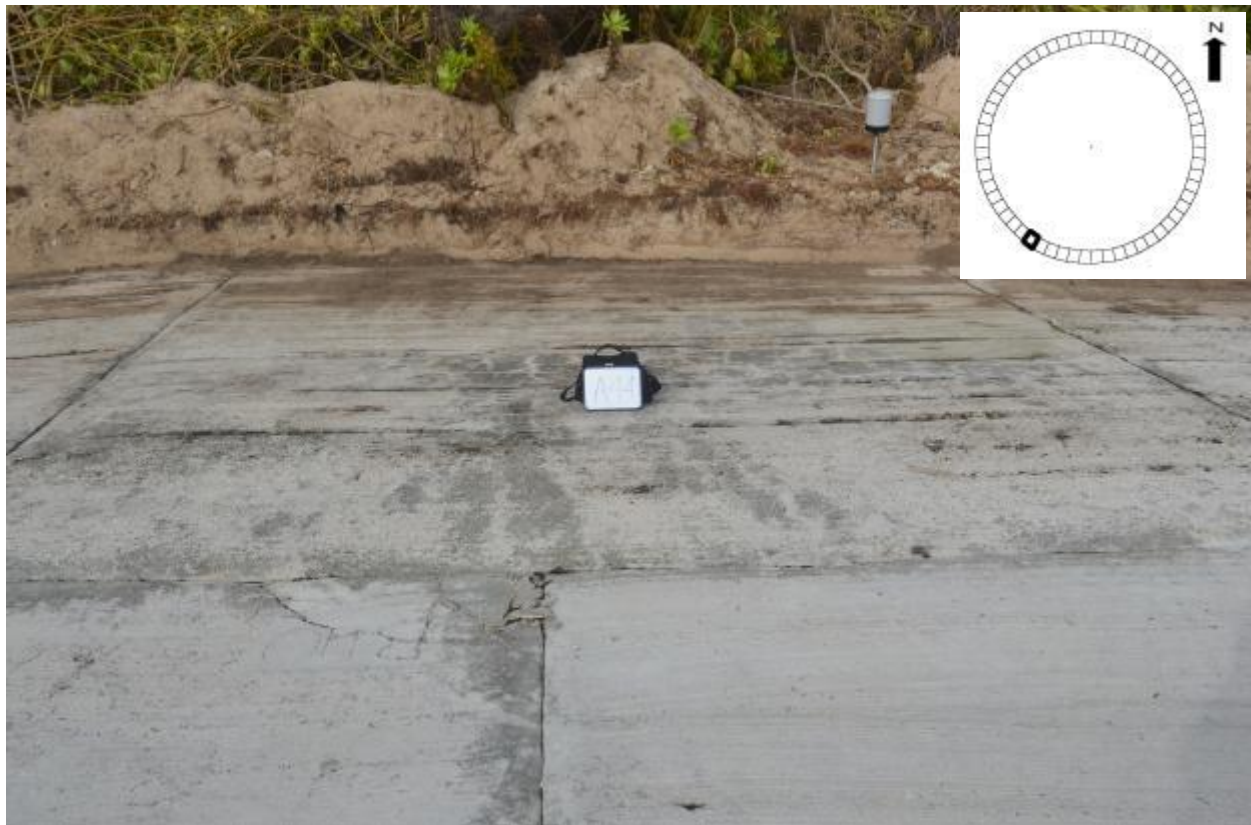
CAP SECTION LOCATION: Panel A44

No significant or obvious interior cracks extending across the top of the panel. The panel has a relatively rough and more weathered appearance. Rooting vegetation removed from along the panel seams..

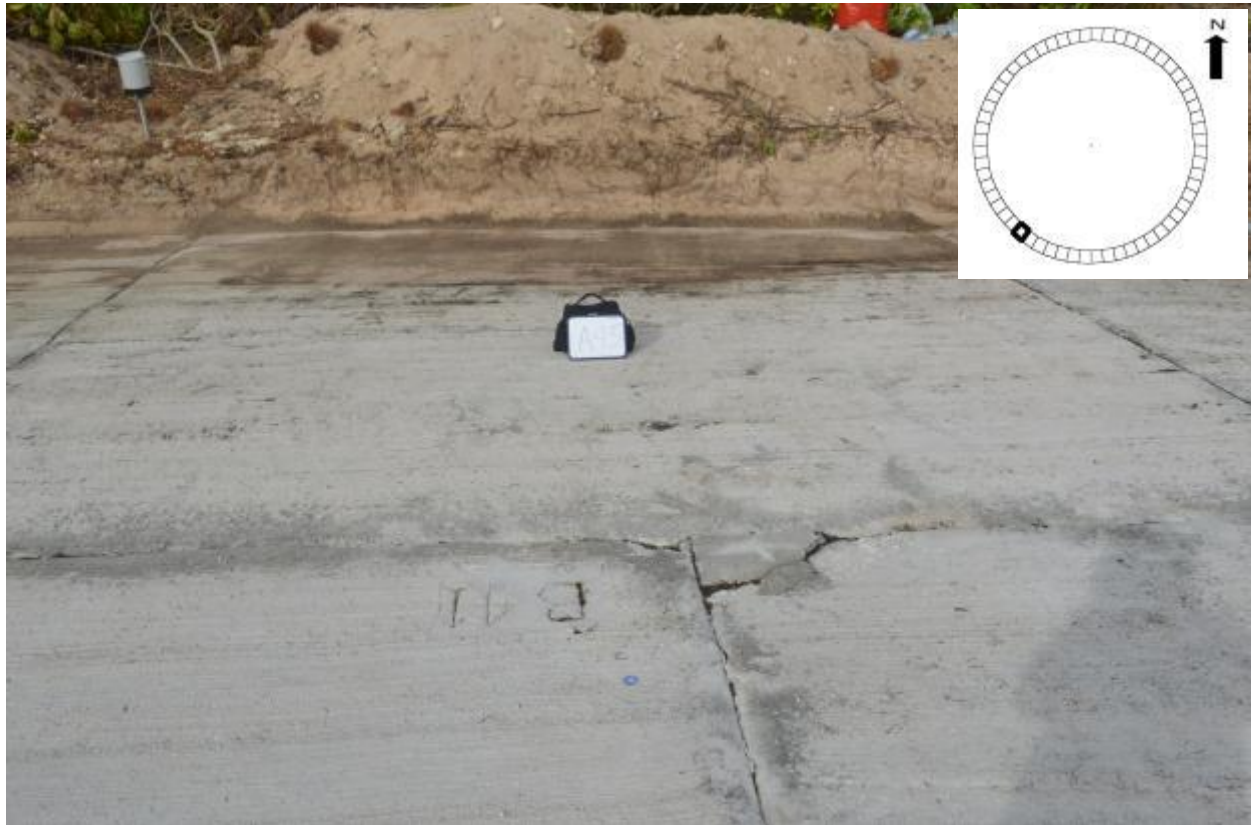
CAP SECTION LOCATION: Panel A45

No significant or obvious interior cracks extending across the top of the panel. Rooting vegetation removed from along the panel seams. There is indication from the GPR data that some areas under the panel are poorly supported or “voided”.

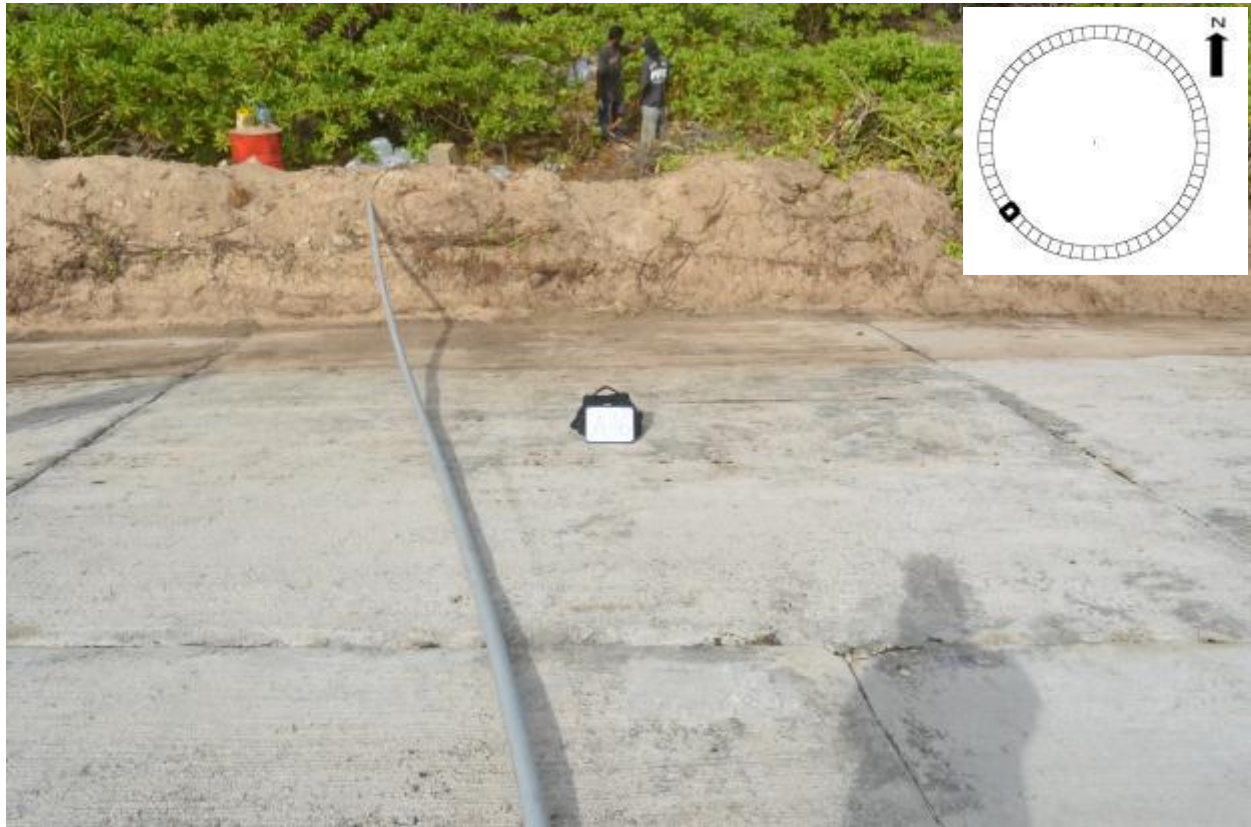
CAP SECTION LOCATION: Panel A46

No significant or obvious interior cracks extending across the top of the panel. Rooting vegetation removed from along the panel seams.

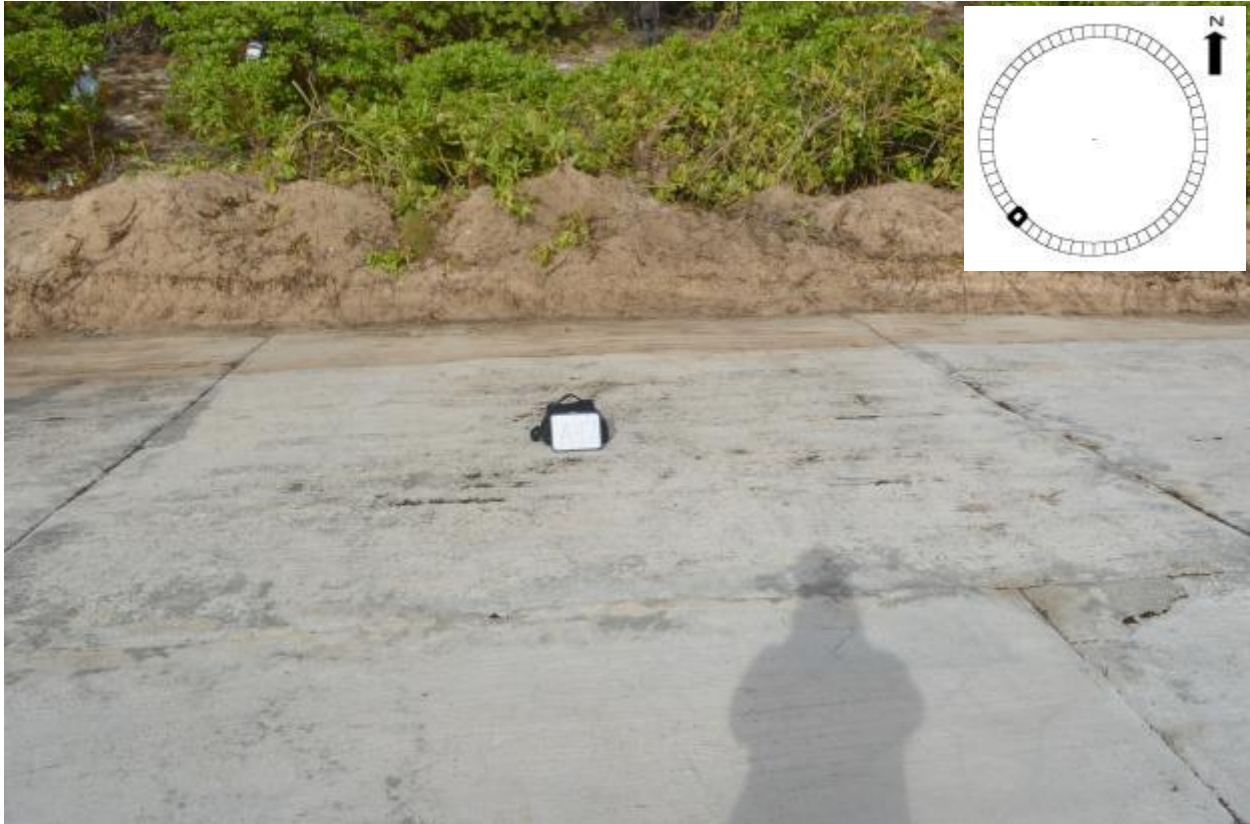
CAP SECTION LOCATION: Panel A47

No significant or obvious interior cracks extending across the top of the panel. Panel has a rough and weathered appearance. Rooting vegetation removed from along the panel seams.

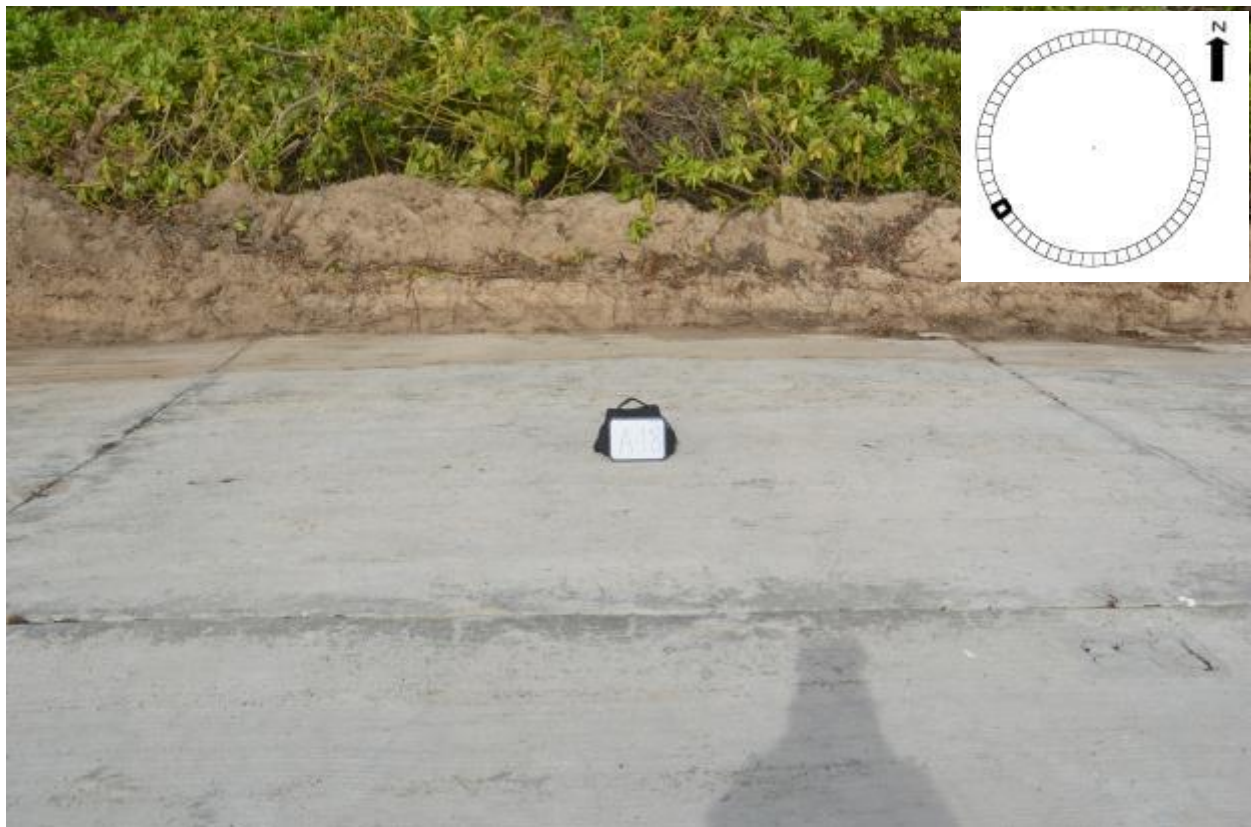
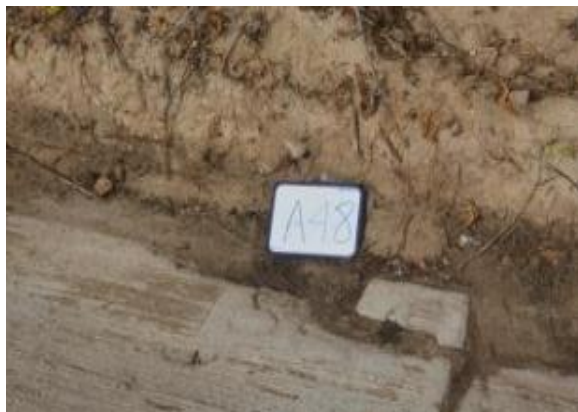
CAP SECTION LOCATION: Panel A48

No significant or obvious interior cracks extending across the top of the panel. Spalling/cracked concrete observed in the lower left-hand corner of the panel, and on the keywall.

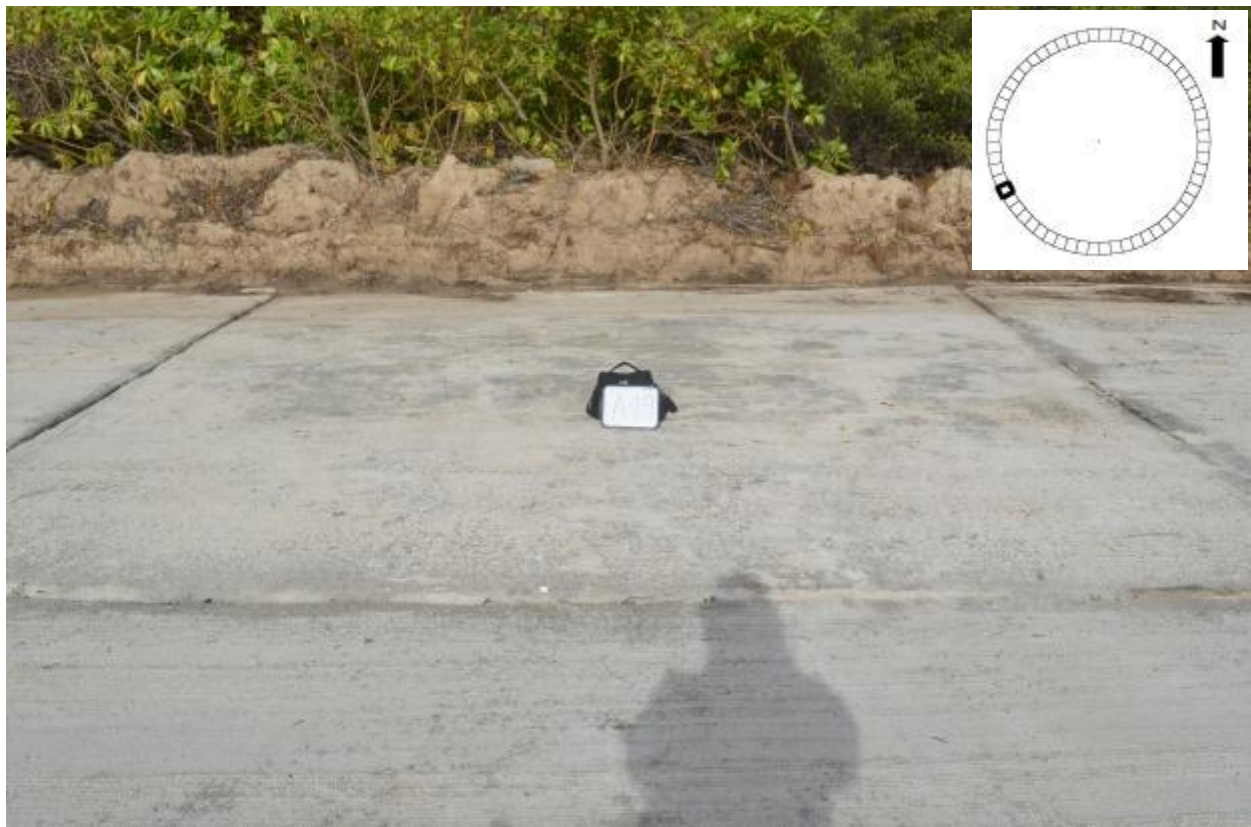
CAP SECTION LOCATION: Panel A49

No significant or obvious interior cracks extending across the top of the panel. Panel has a rough and weathered appearance. Rooting vegetation removed from along the panel seams.

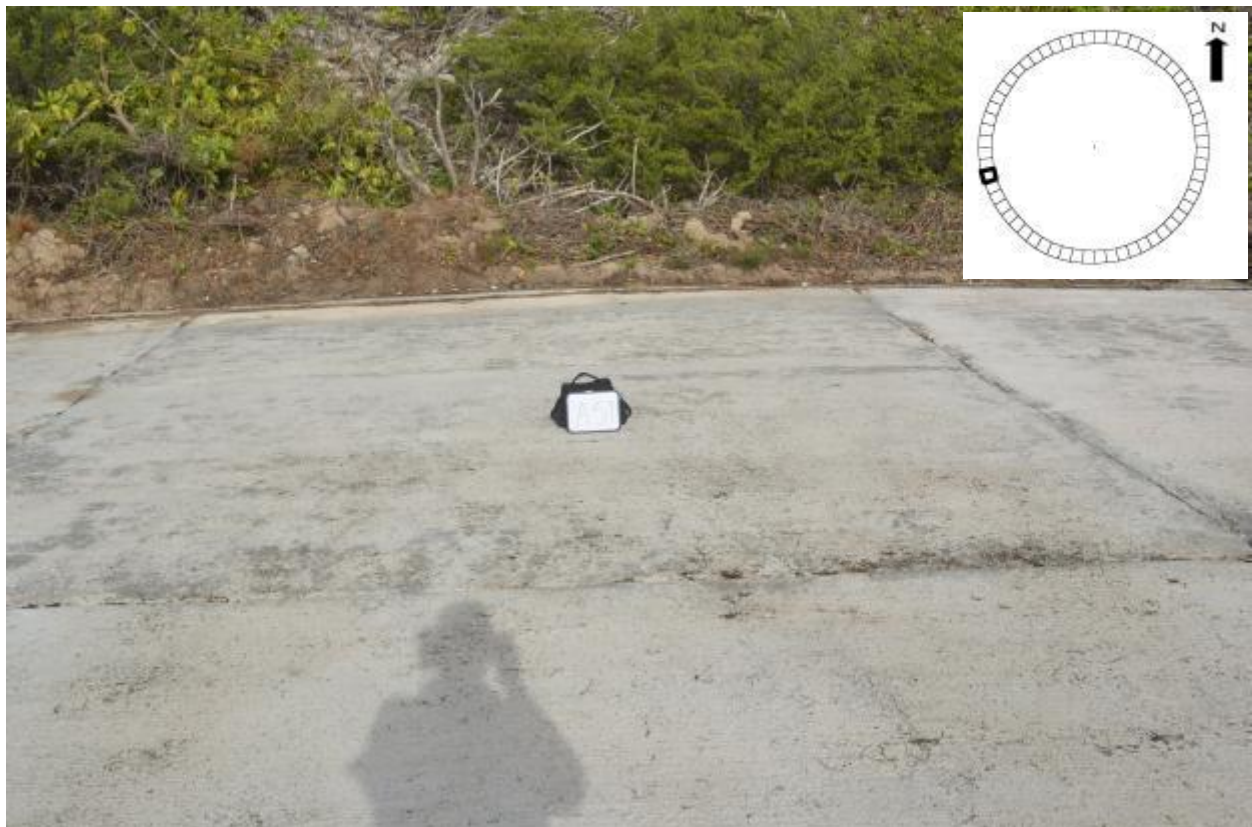
No significant or obvious interior cracks extending across the top of the panel. The panel has a relatively rough appearance. Rooting vegetation removed from along the panel seams. Some minor spalling/chipping of concrete observed in the upper right-hand corner of the panel, and along the panel seams.

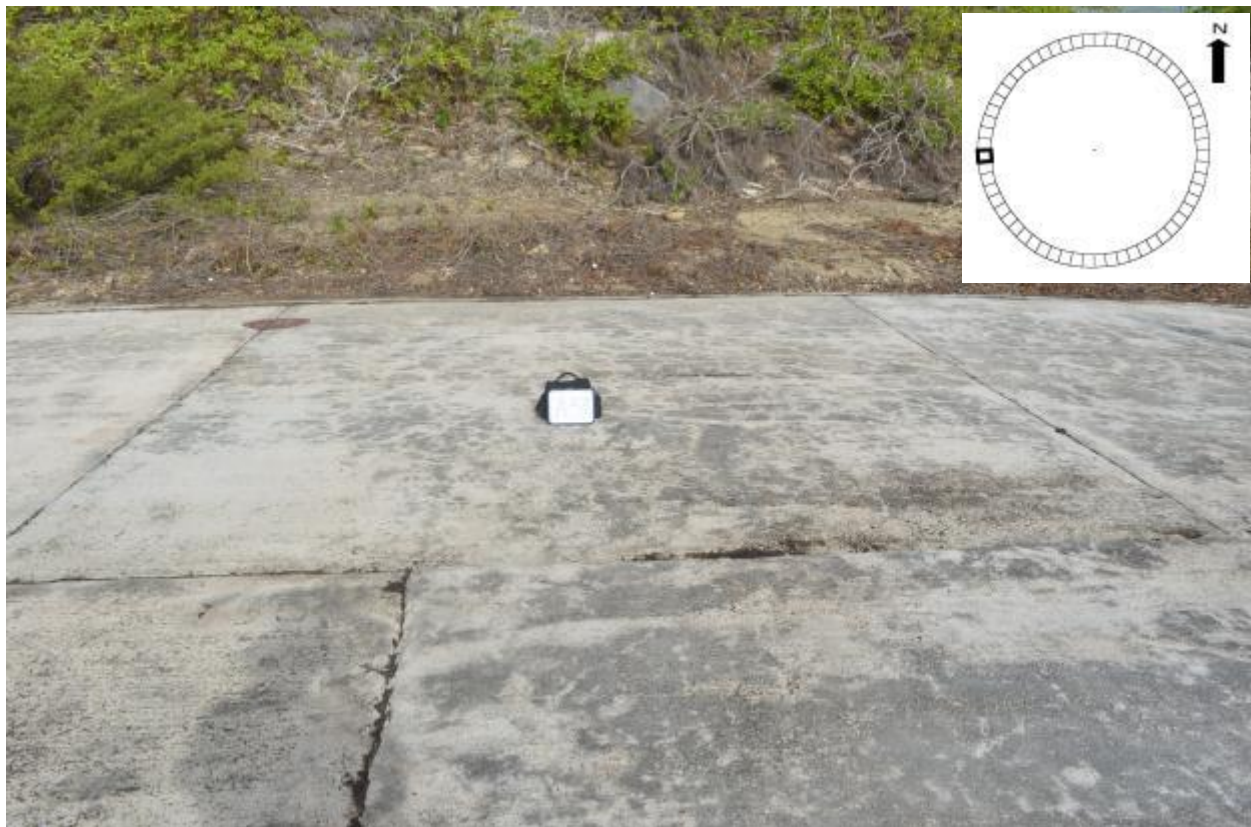
No significant or obvious interior cracks extending across the top of the panel. Panel has a relatively rough appearance. Rooting vegetation removed from along the panel seams. Panel contains a vertical elevation benchmark.

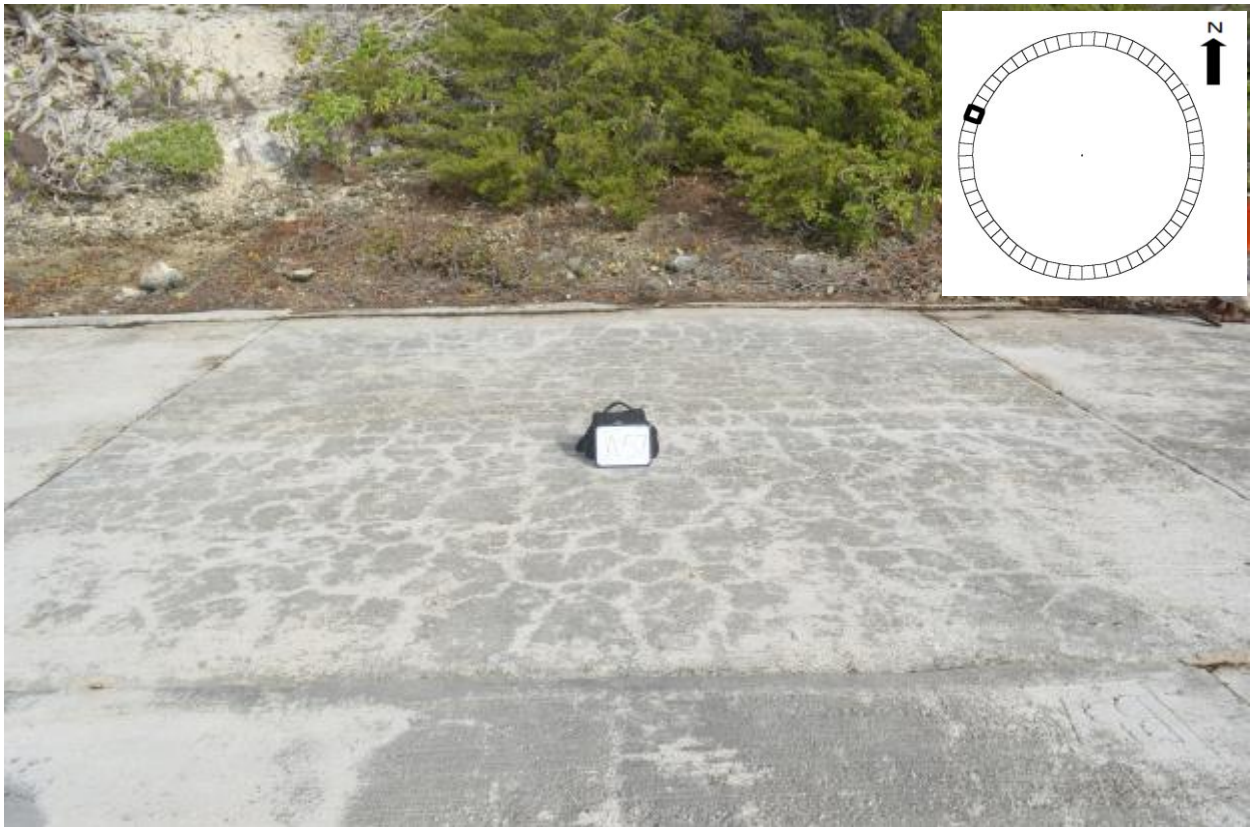
No significant or obvious interior cracks extending across the top of the panel. Panel has a relatively rough appearance. Rooting vegetation removed from along the panel seams.

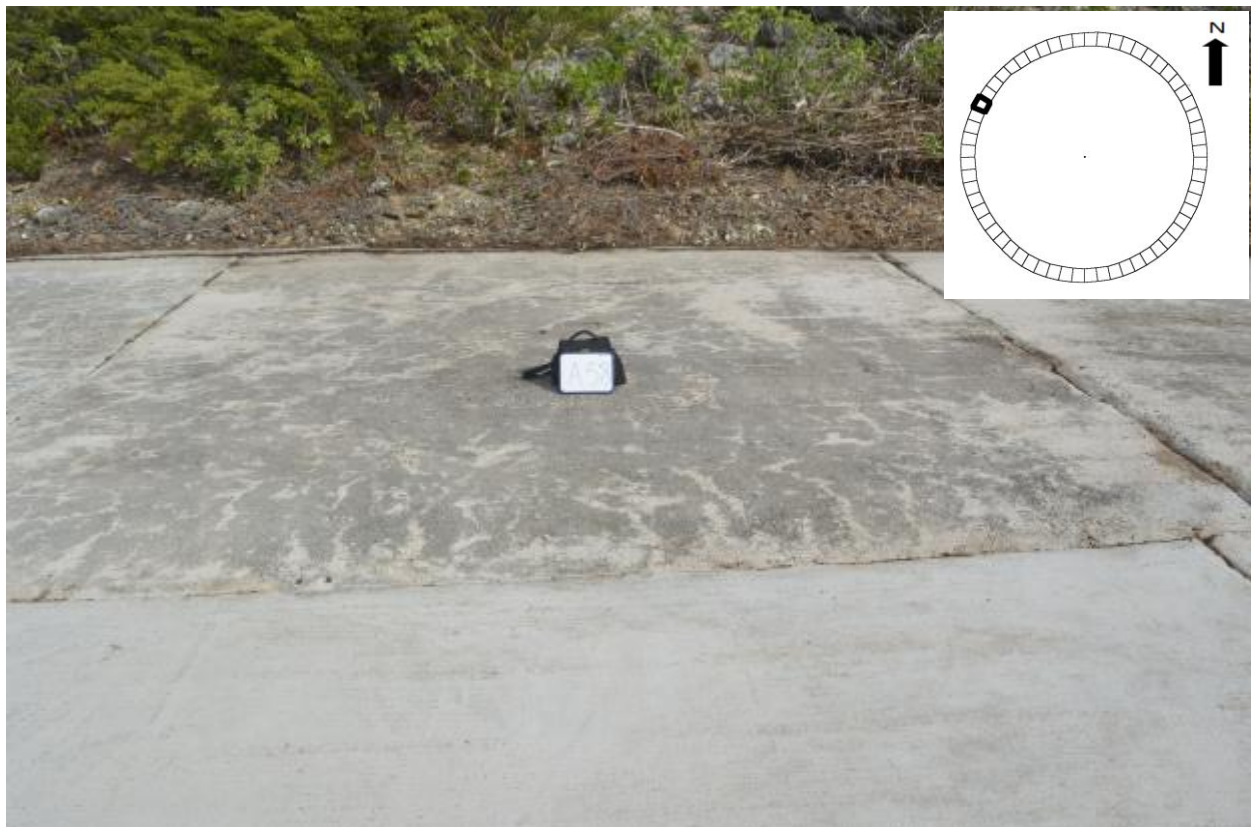
CAP SECTION LOCATION: Panel A58

No significant or obvious interior cracks extending across the top of the panel. Panel has a relatively rough appearance. Rooting vegetation removed from along the panel seams. Some spalling of concrete observed along the bottom seam adjacent to the keywall, and in the top right-hand corner of the panel.

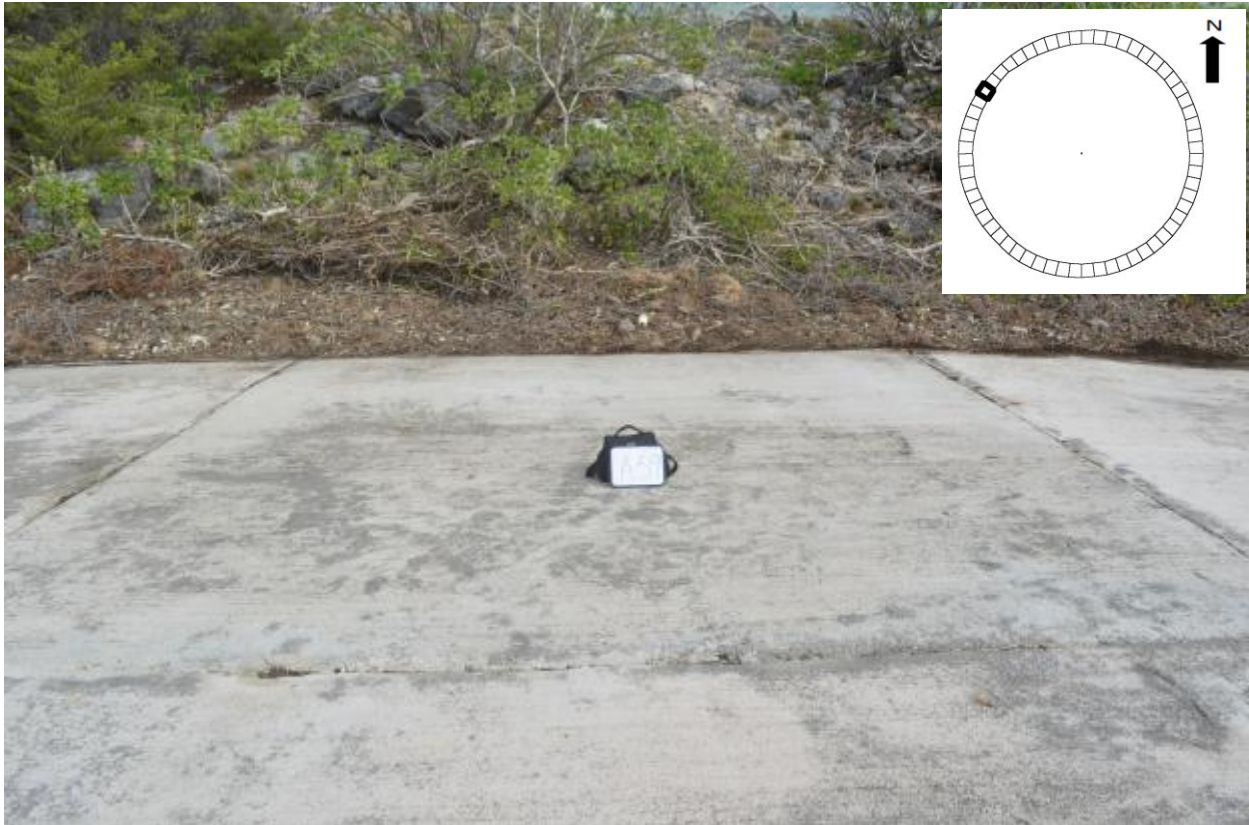
CAP SECTION LOCATION: Panel A59

No significant or obvious interior cracks extending across the top of the panel. Rooting vegetation removed from along the panel seams. Some minor spalling of concrete observed in the upper left-hand corner of the panel.

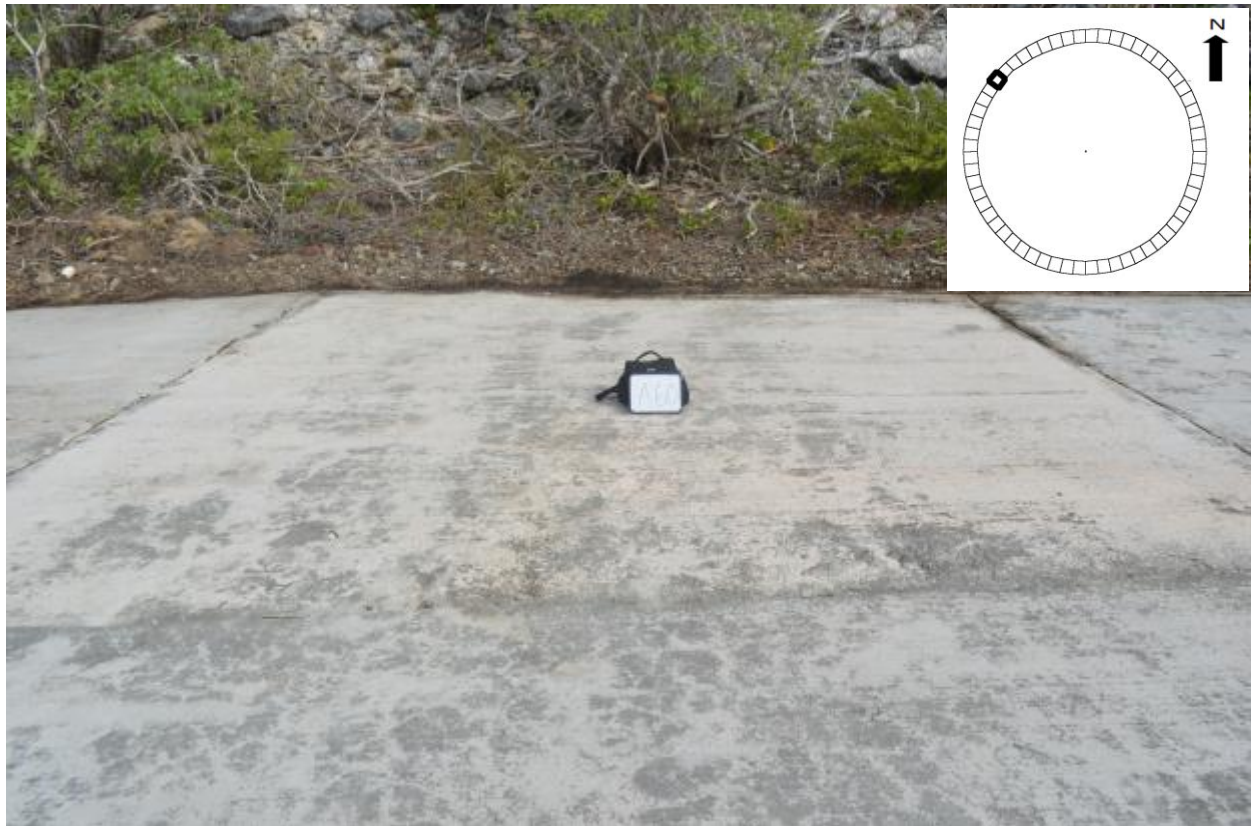
CAP SECTION LOCATION: Panel A60

No significant or obvious interior cracks extending across the top of the panel. Rooting vegetation removed from along the panel seams. Some very minor spalling of concrete observed in the lower right-hand corner of the panel.

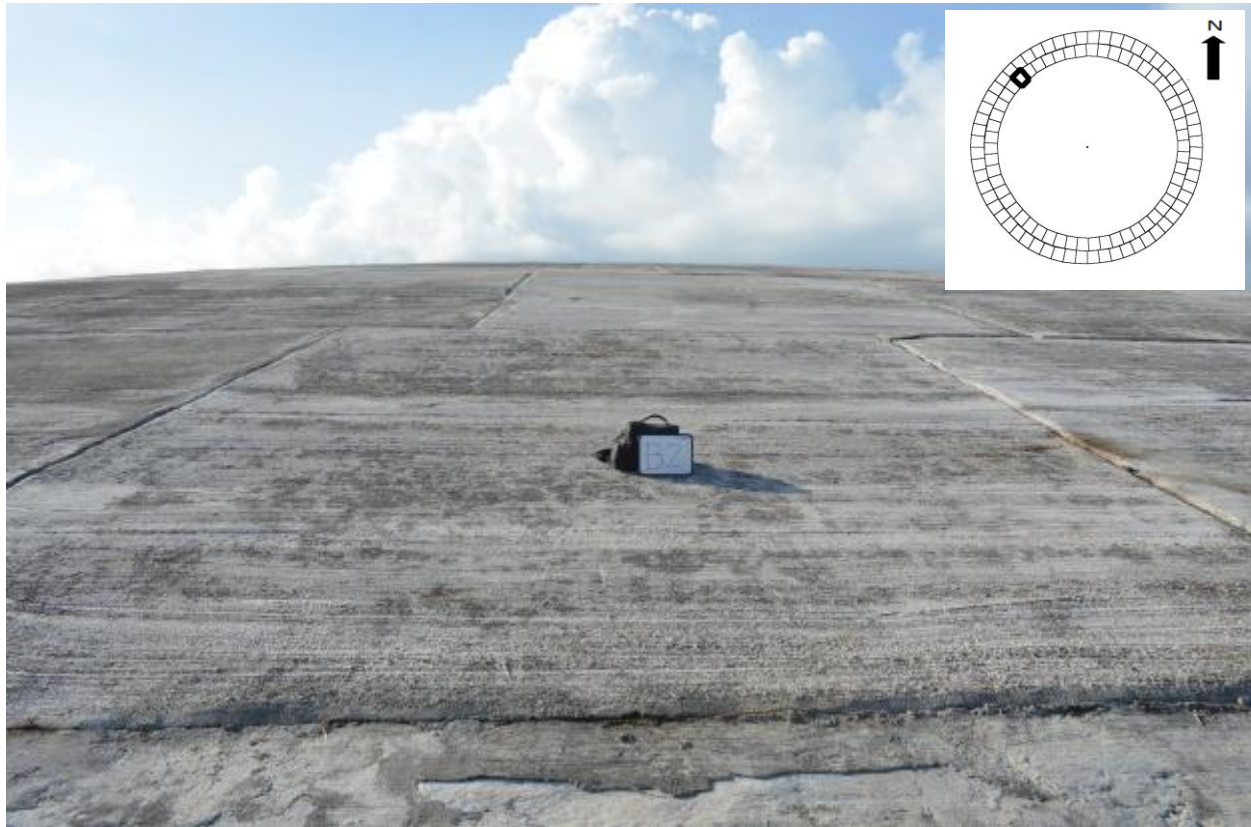
A obvious crack observed running across the full width of the panel in the upper portion of the segment. Rooting vegetation removed from along the panel seams.

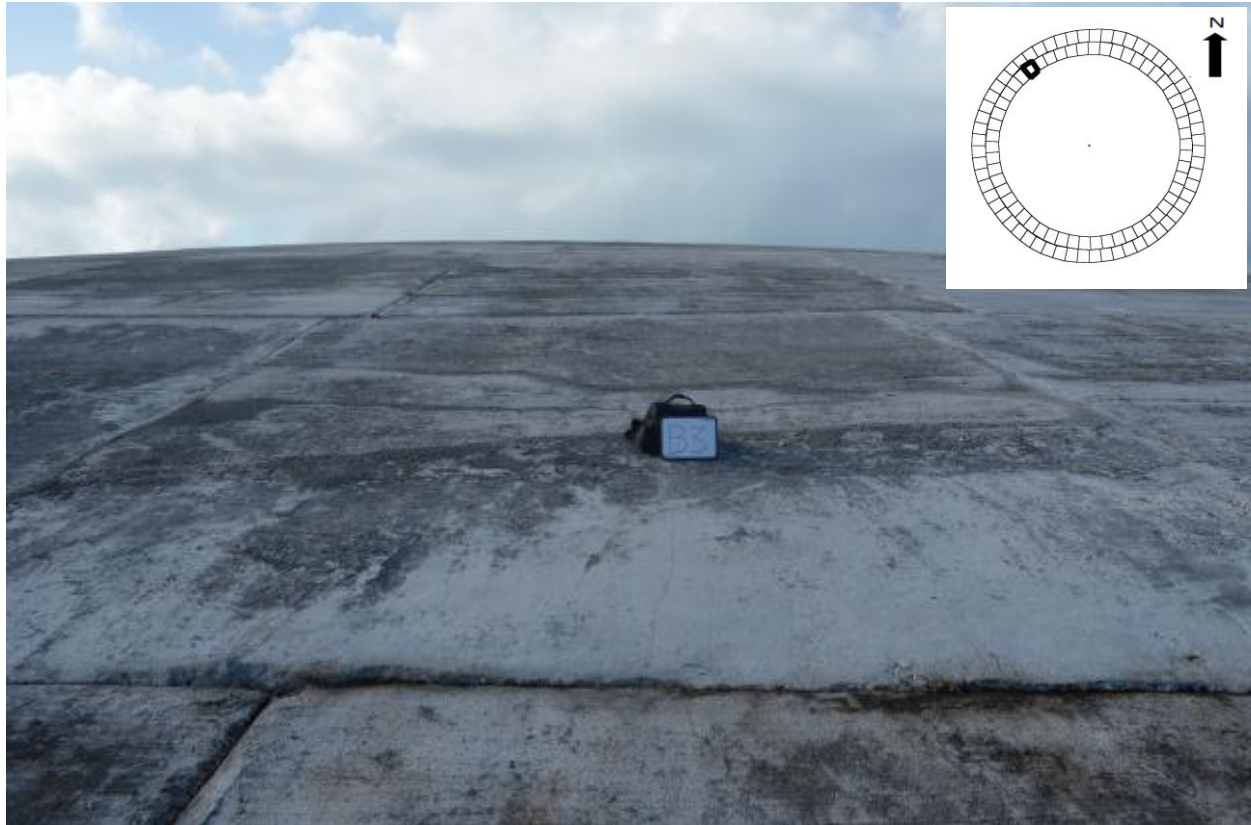
CAP SECTION LOCATION: Panel B3

A crack observed extending up from a mid-point along the bottom seam of the panel branching into a fork at a mid-point up the segment. The panel has a relatively dark and weathered appearance. Rooting vegetation removed from along the panel seams.

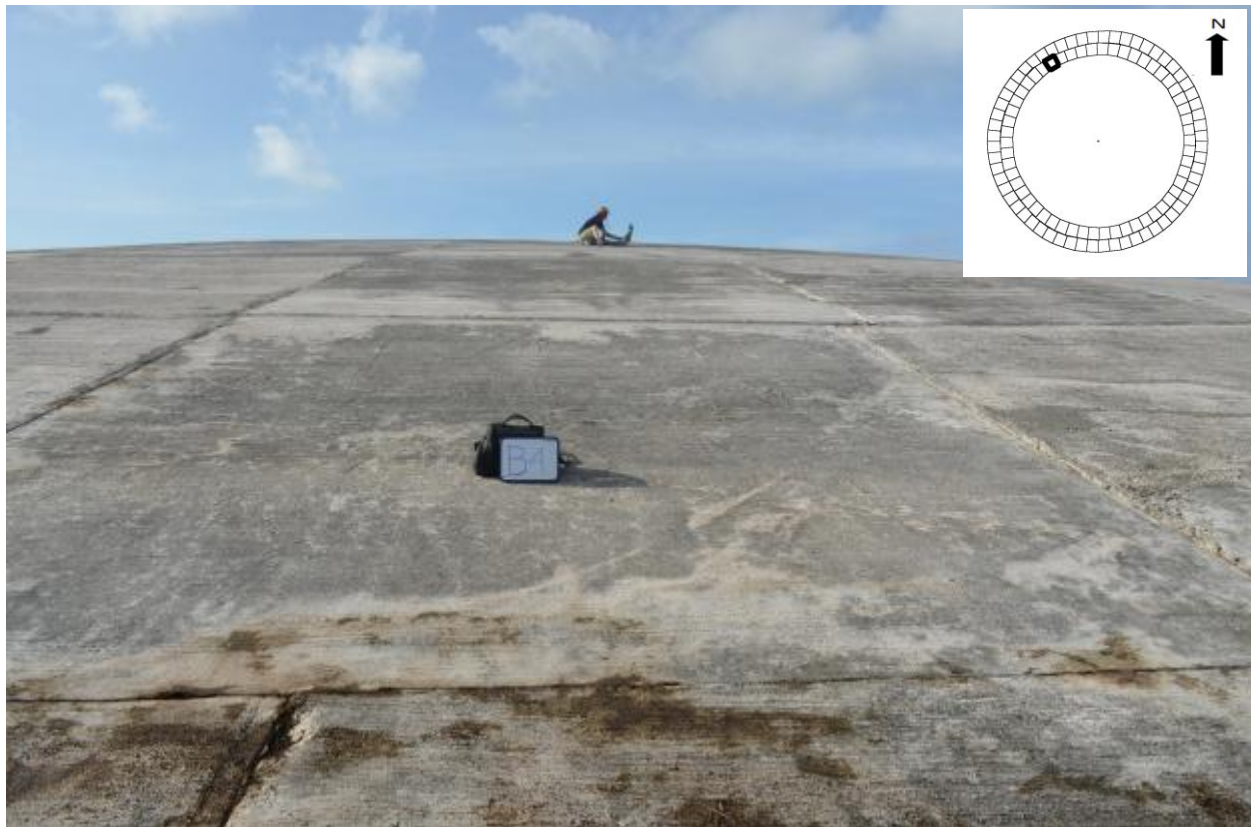
CAP SECTION LOCATION: Panel B4

No significant or obvious interior cracks extending across the top of the panel. The panel appears dark and weathered. Rooting vegetation removed from along the panel seams.

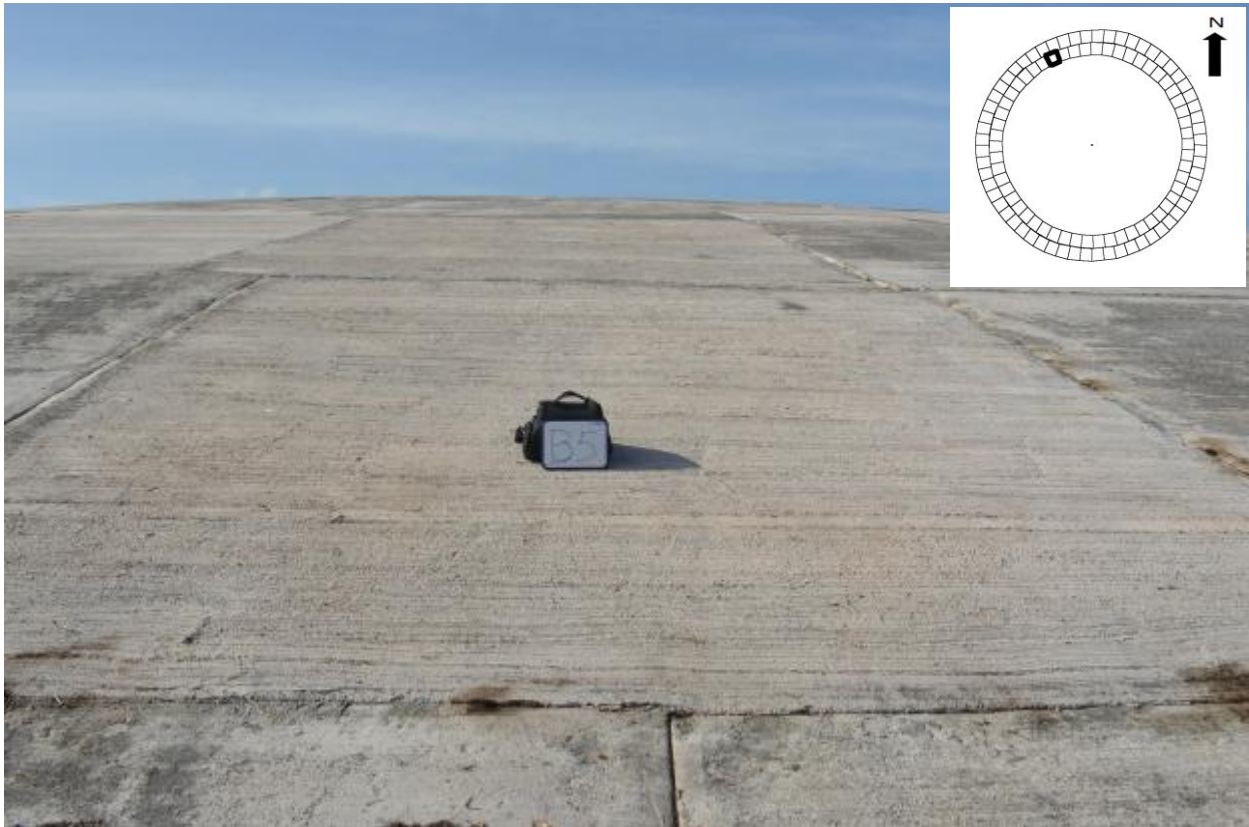
CAP SECTION LOCATION: Panel B5

No significant or obvious interior cracks extending across the top of the panel. Rooting vegetation removed from along the panel seams.

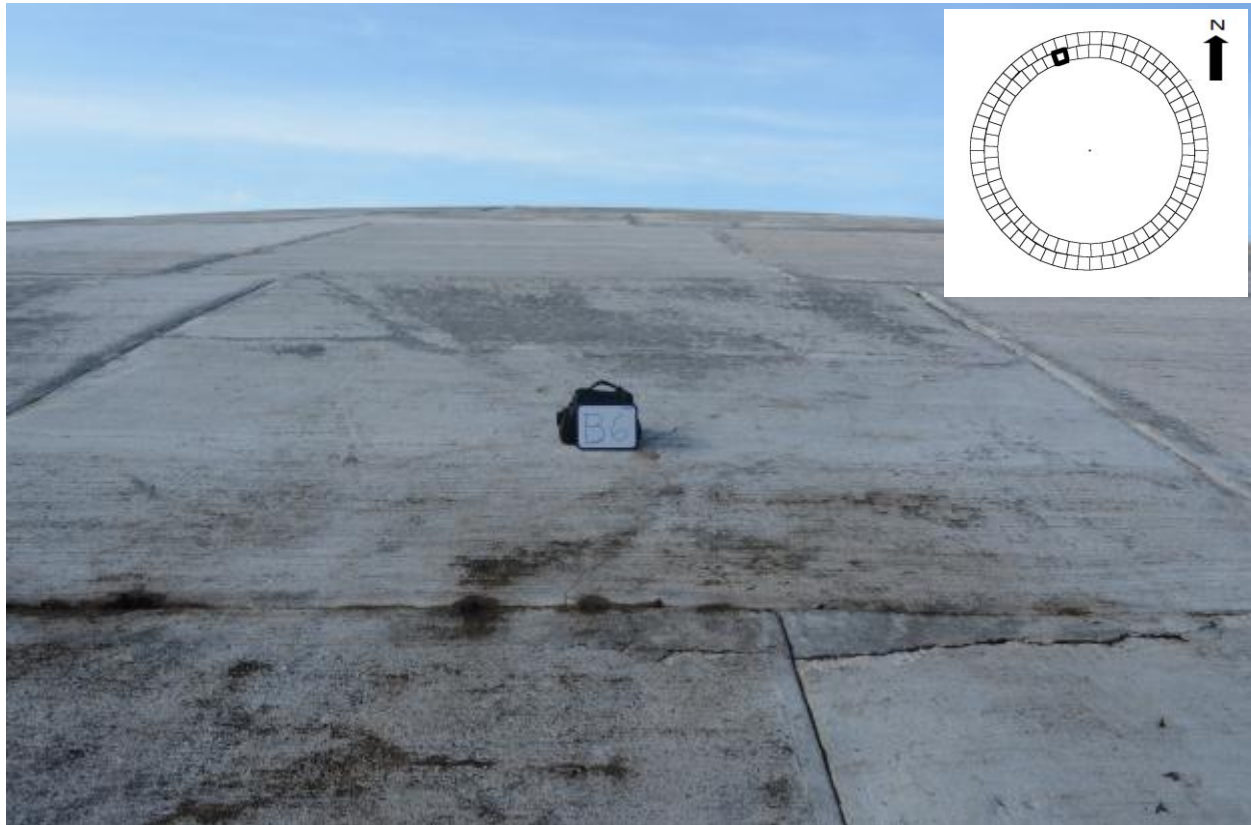
CAP SECTION LOCATION: Panel B6

A crack observed extending up about 1.5 meters from a mid-point along the bottom seam of the panel and branching out to the left and right. The right fork intersects the right edge at a mid-point up the panel while the left fork extends up towards the upper left-hand corner. Rooting vegetation removed from along the panel seams.

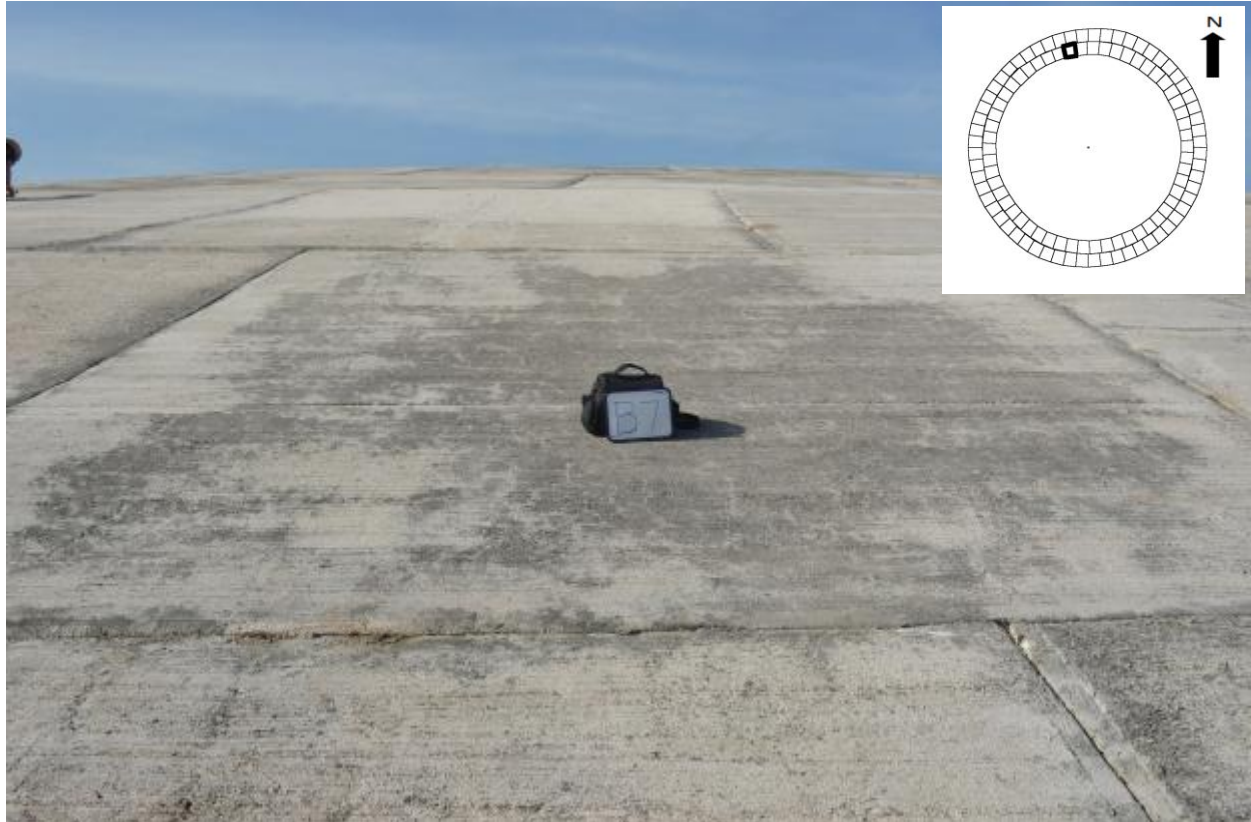
CAP SECTION LOCATION: Panel B7

No significant or obvious interior cracks extending across the top of the panel. Rooting vegetation removed from along the panel seams.

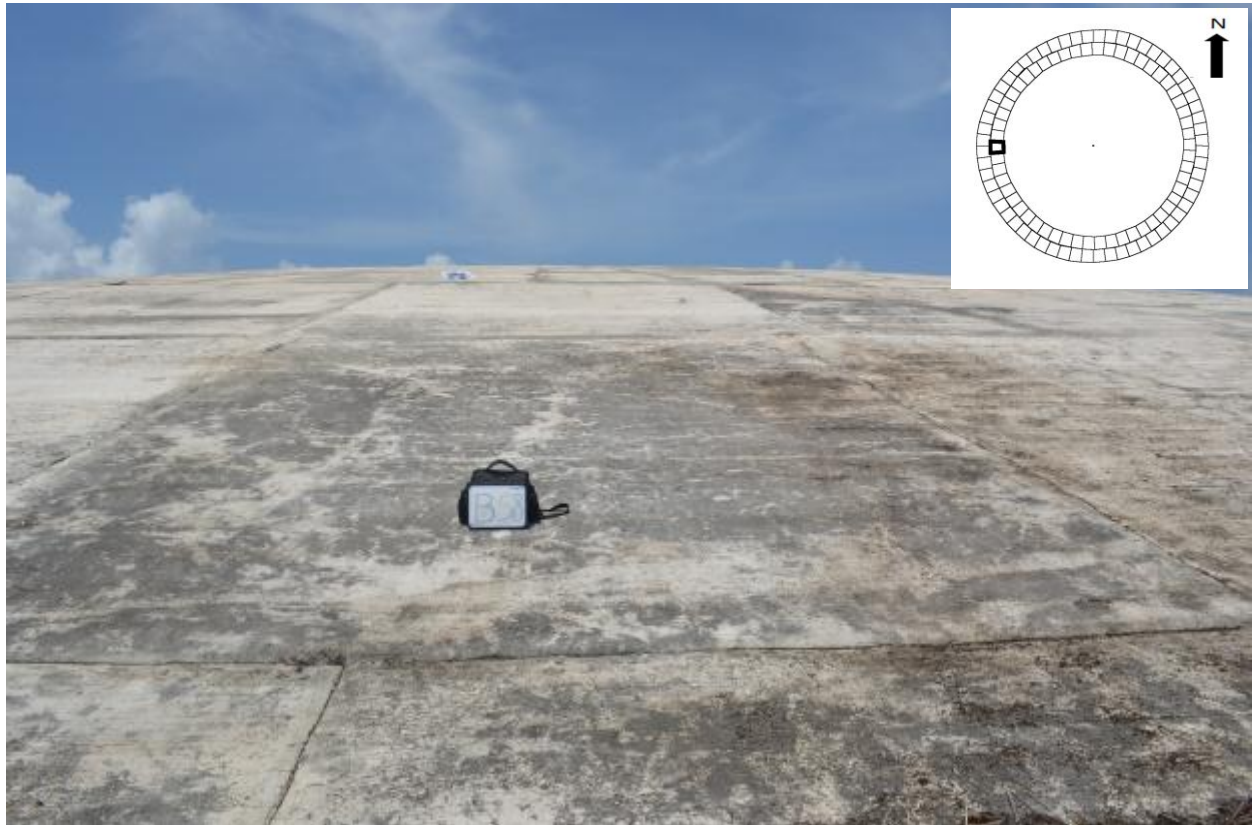
CAP SECTION LOCATION: Panel B55_duplicate

No significant or obvious interior cracks extending across the top of the panel. Rooting vegetation removed from along the panel seams.

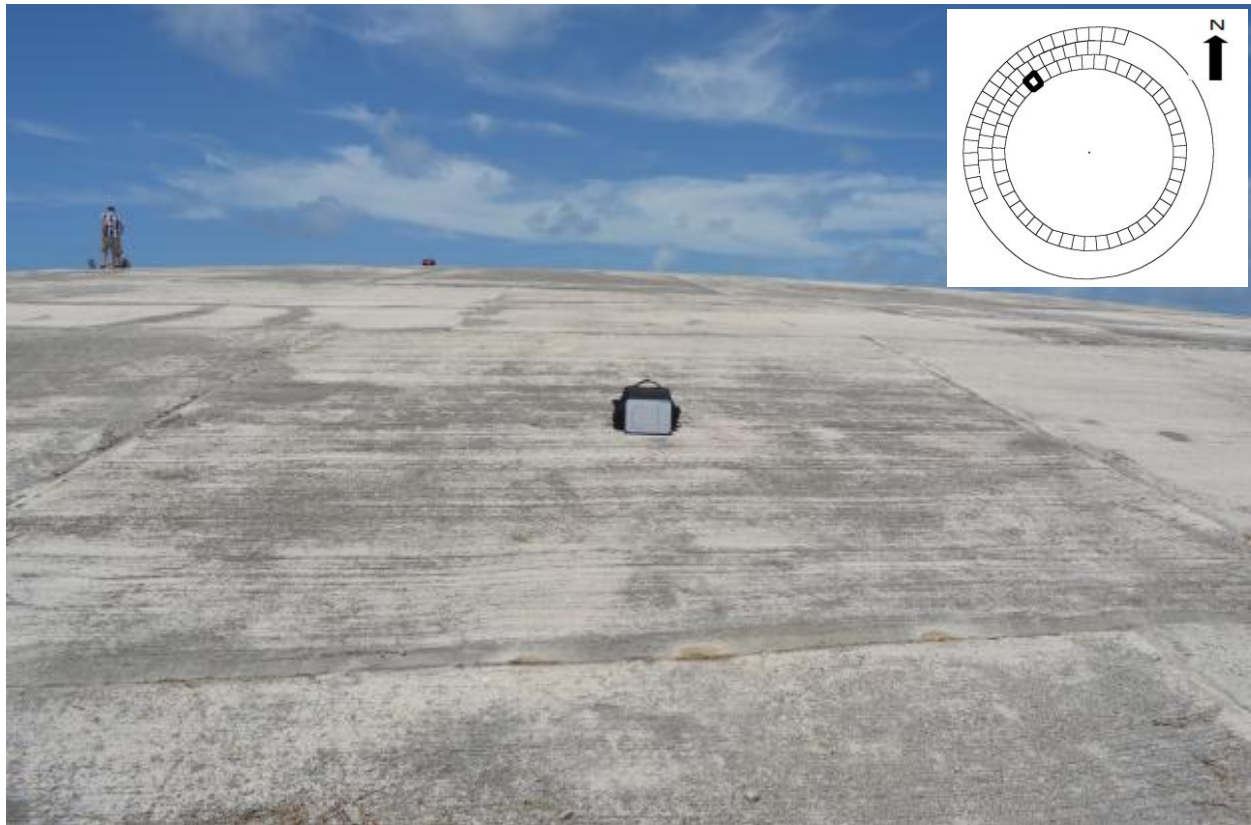
CAP SECTION LOCATION: Panel C2

No significant or obvious interior cracks extending across the top of the panel. The panel has a slightly more rough and weathered appearance. Rooting vegetation removed from along the panel seams.
